DEPARTMENT OF NATURAL RESOURCES AND CONSERVATION  
DAM SAFETY INSPECTION

NAME OF DAM Ruby Dam  
DATE INSPECTED October 6, 2008

INVENTORY NO. MT 4  
HAZARD CATEGORY HIGH  
TYPE OF DAM Earth  
YEAR BUILT 1938

## Ruby Dam 2008 Annual Inspection Photographic Log

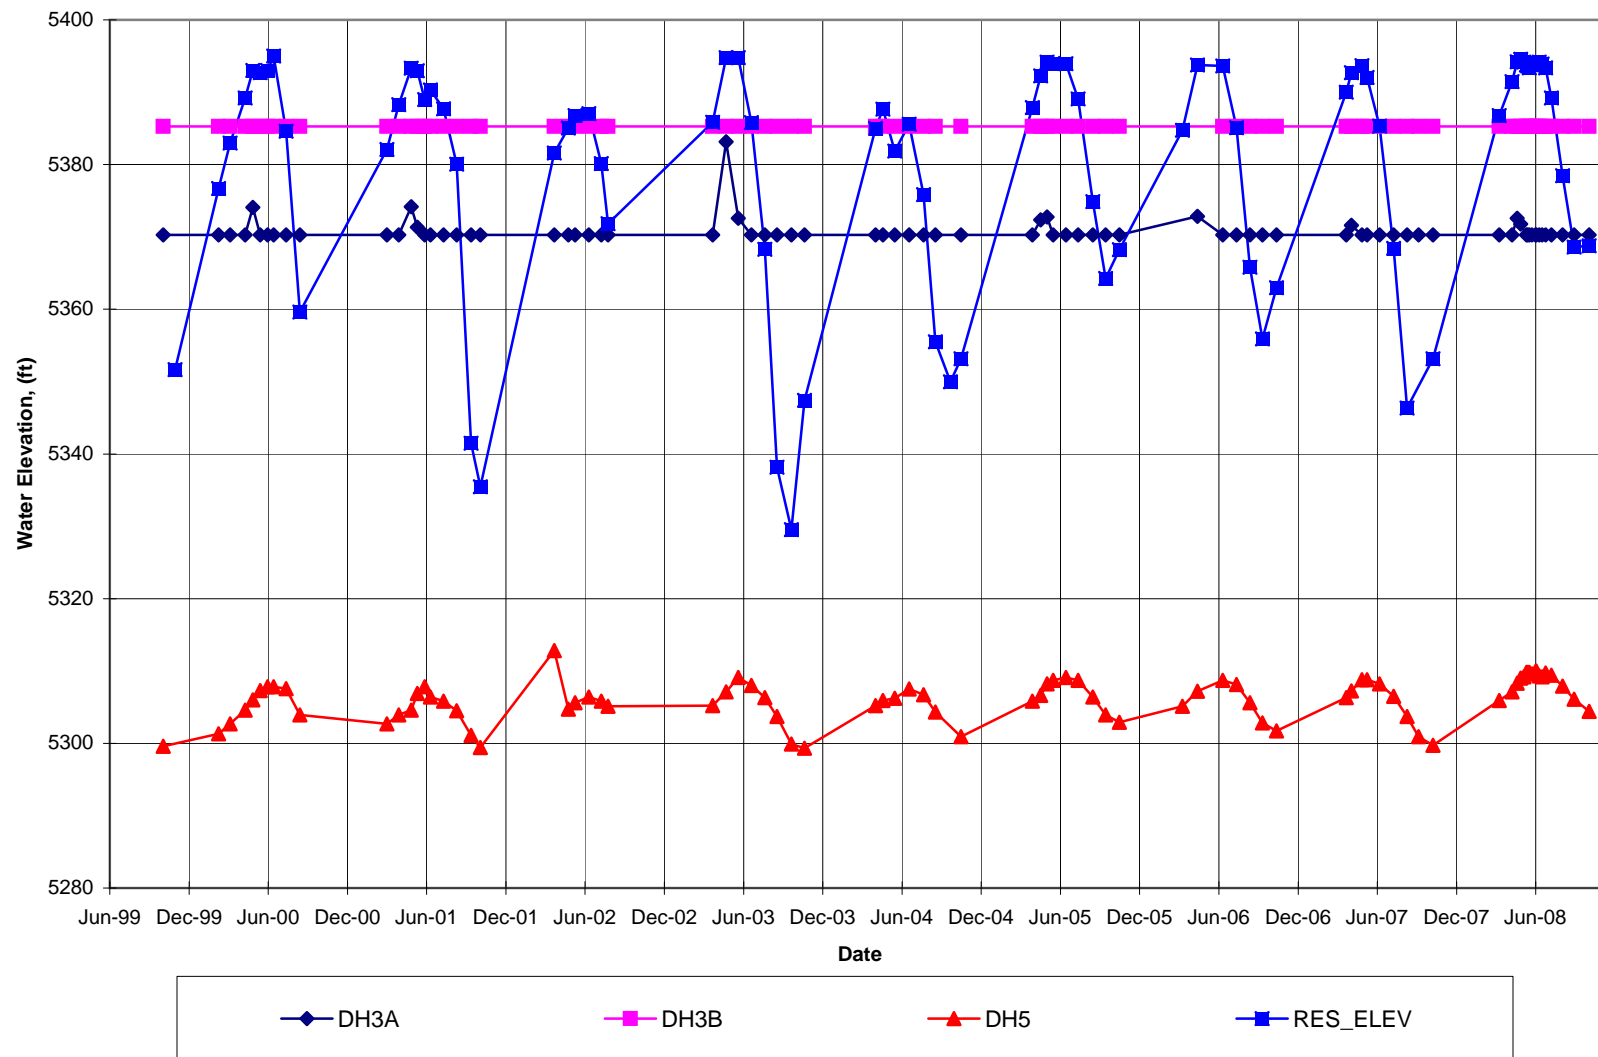
FIGURE 2 - RUBY RESERVOIR - Left of Outlet

**Section 6.(A).** In the fall of 1999, 13 piezometers were installed in 7 drill holes. They are located in the spillway approach channel, through the dam crest, and at the toe of the dam (see Figure 1.) The most recent piezometers and reservoir elevation data is shown in Figure 2, 3 and 4.
